FLASH FLOODS IN HIMALAYA WITH SPECIAL REFERENCE TO MORI TEHSIL OF UTTARAKHAND, INDIA

SUSHIL KHANDURI¹, K. S. SAJWAN²

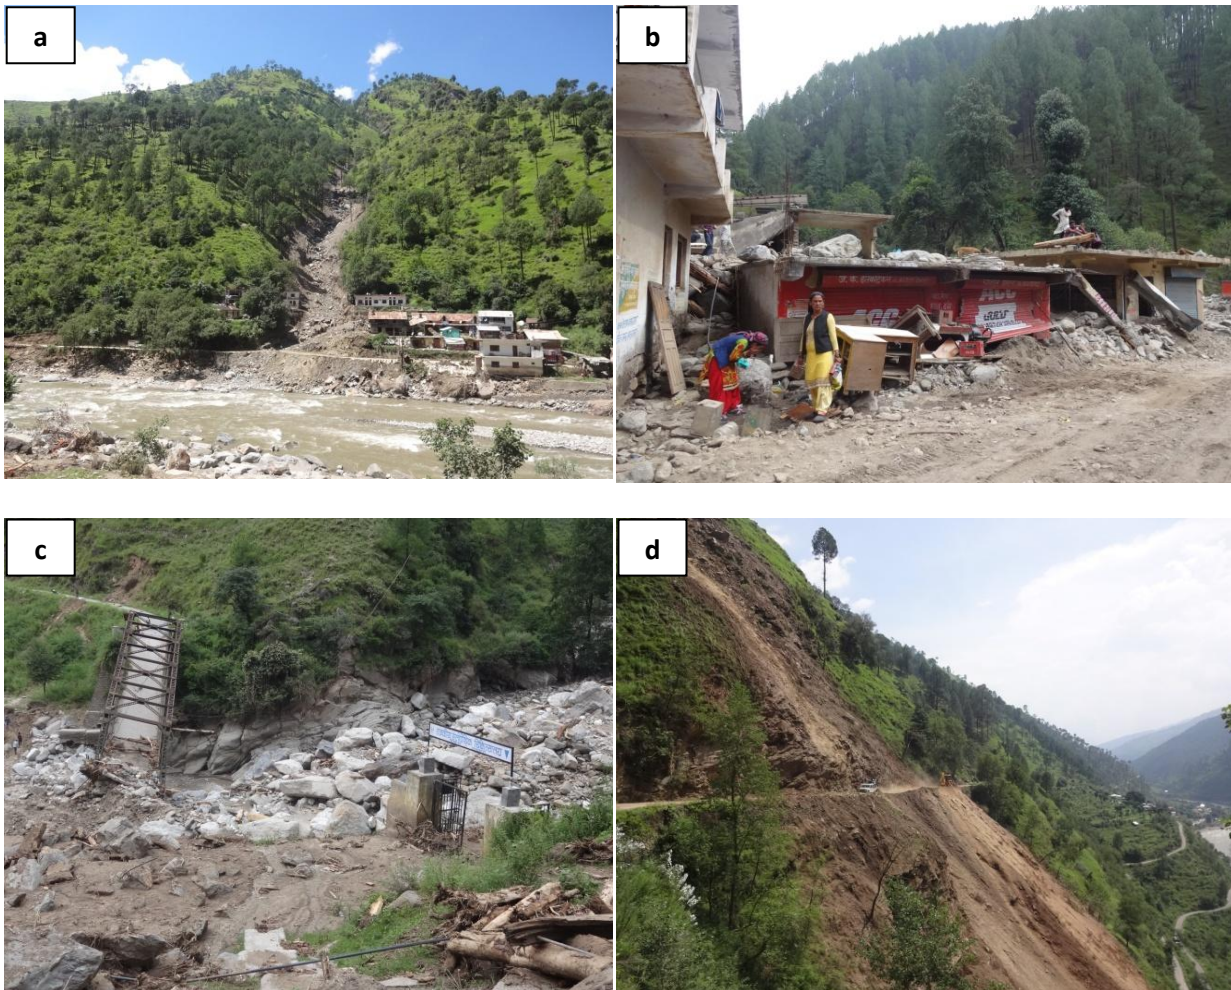
Figure 2: On 18th August, 2019 hydro-meteorological disaster induced losses; (a) high velocity discharge through local streams damaged road and other structures in Arakot; (b) damaged shops due to debris flows in Tikochi village; (c) damage to bridge and washed away Allopathic Hospital due to flash floods at Tikochi village; (d) road leading to Arakot-Chiwan blocked due to landslide; (e) vehicles washed away due to breaching of road and debris flows; (f) crashed helicopter of Heritage Aviation in the affected area

According to eyewitness accounts cloudburst incidence took place around Arakot along with Khaneda Gad valley after heavy rainfall in the morning hours (around 0445 hr) in which Arakot, Mauldi, Makuri, Tikochi-Nagwara, Snail, Duchanu etc. villages were severely affected and devastated. Heavy rainfall/Cloudburst like incidences took place in two phases, in first phase at 4.45 AM on 18th August, 2019 Khaneda Gad valley devastated by heavy downpour and associated flash floods afterwards in second phase on the same day at 6.00 AM extreme weather events occurred at Arakot and Snail area. Unprecedented damage and destruction occurred in the Khaneda Gad valley. It has been observed during field investigation that Khaneda Gad a tributary of Pabbar River has changed its course and shifted at several locations, due to heavy discharge. These caused loss of human life, property and infrastructure in the area. High sediments laden discharge through steep gradient streams in the area around Arakot washed away road which lead to Himachal Pradesh and damaged many structures which was exist its flanks (Figure 2a).

Continuous localised precipitation in the catchment of Khaneda valley caused spate in its course that has considerably changed the original topography of the area. Major destruction and damages have been occurred in Tikochi village (Figures 2b and 2c). Besides, Chiwan, Gokul, Jhotadi, Balawat, Moldi, Jagta, Dhara, Dagali, Duchanu, Monda, Kalich, Makuri and Barnali villages are adversely affected. The landslides and toe erosion by the streams caused breaching of the road and overran the vehicles in the area (Figures 2d and 2e).

One helicopter of Heritage Aviation crashed in the affected area while engaged in relief and rescue operations (Figure 2f). 3 persons onboard the ill fated chopper including Pilot and Co-Pilot died in the incidence. Detail of the losses is given in Table 3.
